**The Corporation of the Municipality of Wawa
Staff Report**

Prepared For: Corporate Planning Cmte.	Report No.: AP 2023-10
Agenda Date: September 19, 2023	File No.: C11

This report concerns maintenance standards along the Highway 101 corridor in front of the Wawa Tourist Information Centre (TIC).

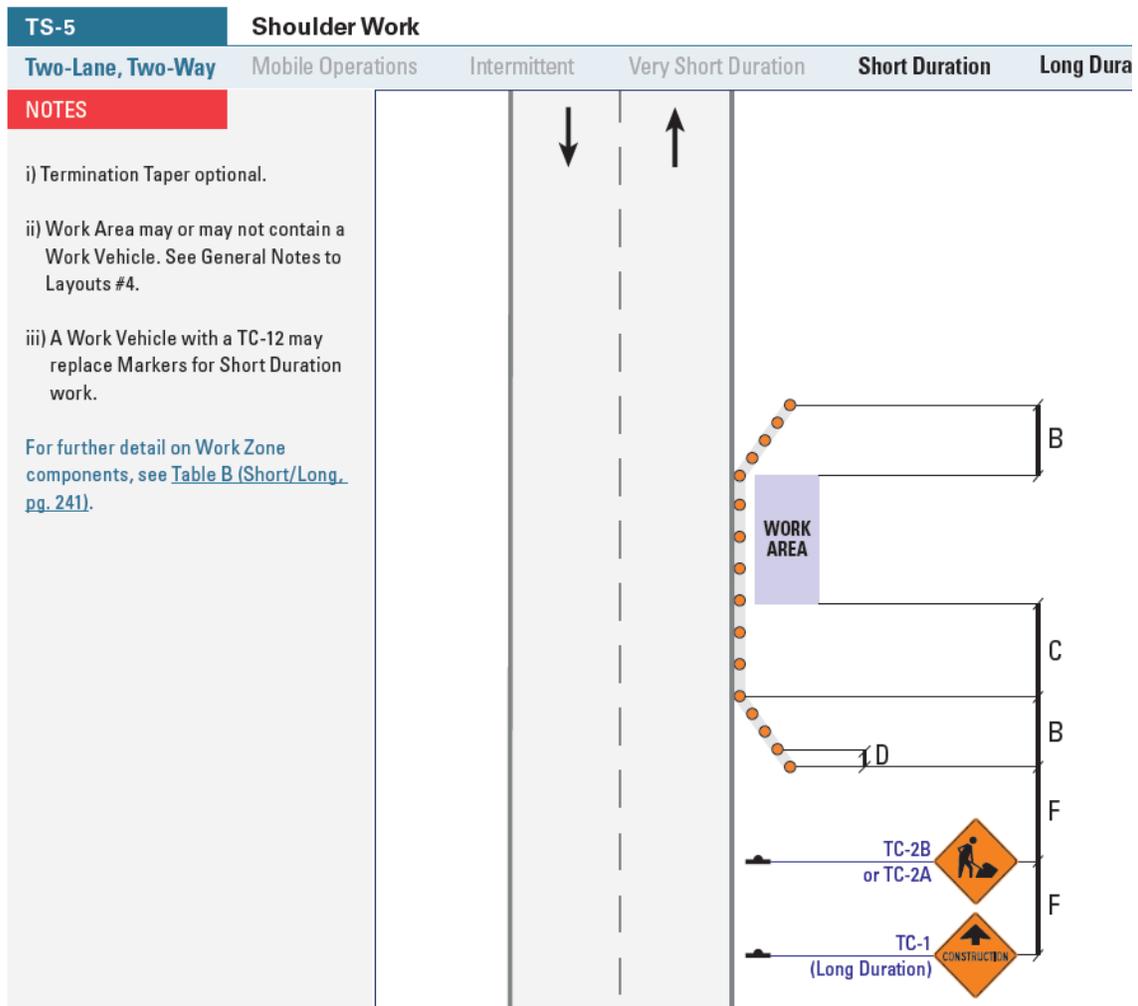
The setup required has been a subject of discussion, therefore staff have included the relevant diagram for the work required:

The requirement to use this diagram for setup has been confirmed by Workplace Safety North, who provided staff with training. For the section between the TIC driveway and Highway 101, it will require the setup of 54 cones at the prescribed spacing in the diagram, and the completion of a Traffic Protection Plan as per SOP-005 Traffic Control. Staff working in and around the area will require training to these standards, including all summer students.

Maintaining the corridor typically involved summer students and on occasion full time staff using string trimmers to cut along the ditch from the TIC to the highway. This places these staff at risk of both vehicles and debris coming off the roadway, as well as holds additional setup requirements as per the Ontario Traffic Manual Book 7 (Book 7).

WSN confirmed that the traffic diagram was correct to use in the location as presented.

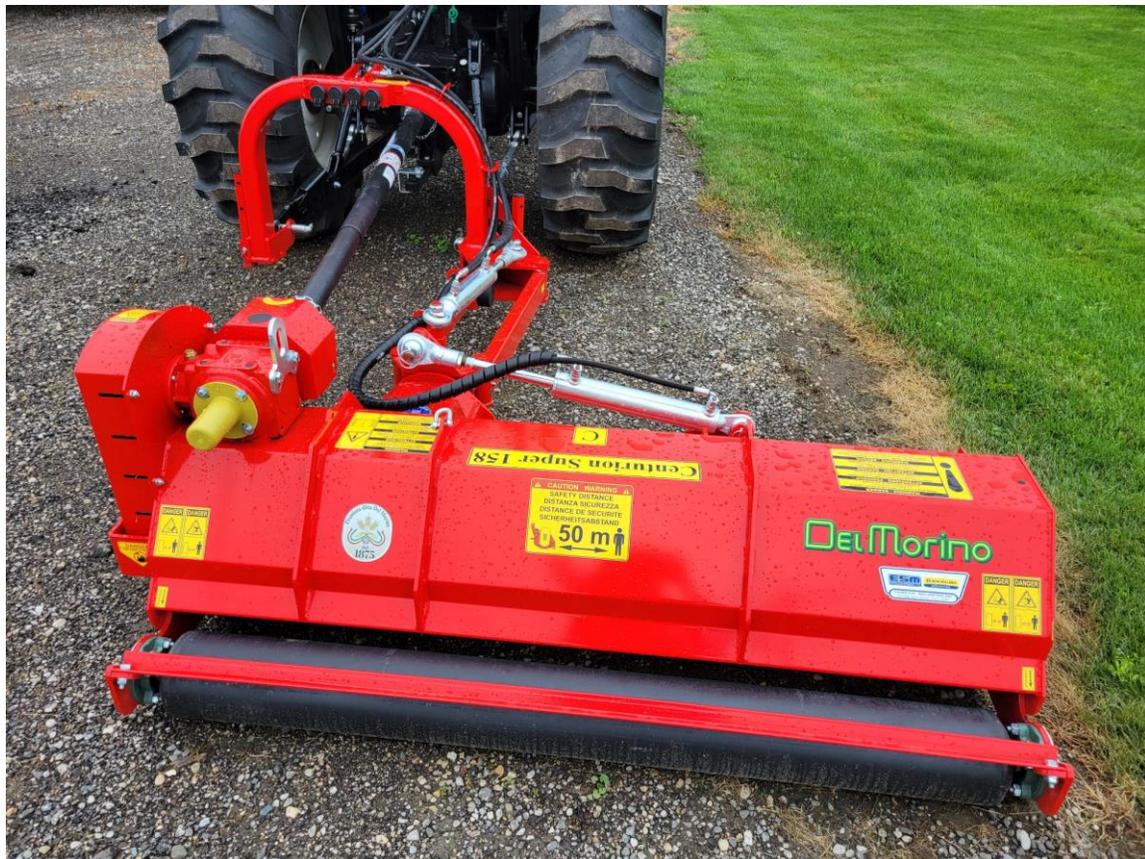
Staff also investigated the possibility of a ditch mowing attachment. There are several market options for existing municipal units including the trackless, mini-excavator, and the New Holland operated by the department that could be used here and in other locations around the Municipality. A ditch mower was quoted to the Municipality for the New Holland at under \$10,000 and is pictured below:

For the purchase of a ditch mower attachment, a budget of \$7,500+HST was provided to staff by ESM farm equipment, a preferred supplier. An RFQ process would be required for a final cost estimate. Other options including trackless and mini-excavator mowers would have greater power and range, with a budget estimate ranging from \$10,000 to \$15,000 and would be subject to capital purchasing in the 2024 budget. There are currently no funds set aside for additional attachments.
